# **From Crash Reports to Safer Roads:**

## **A Multimodal Framework Integrating Vision-Language Models and Street View Analysis**

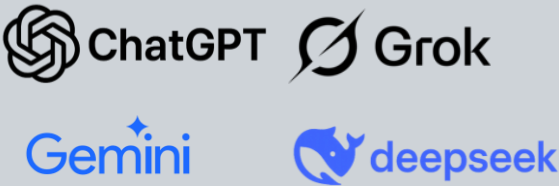
## Proportion of Root Cause

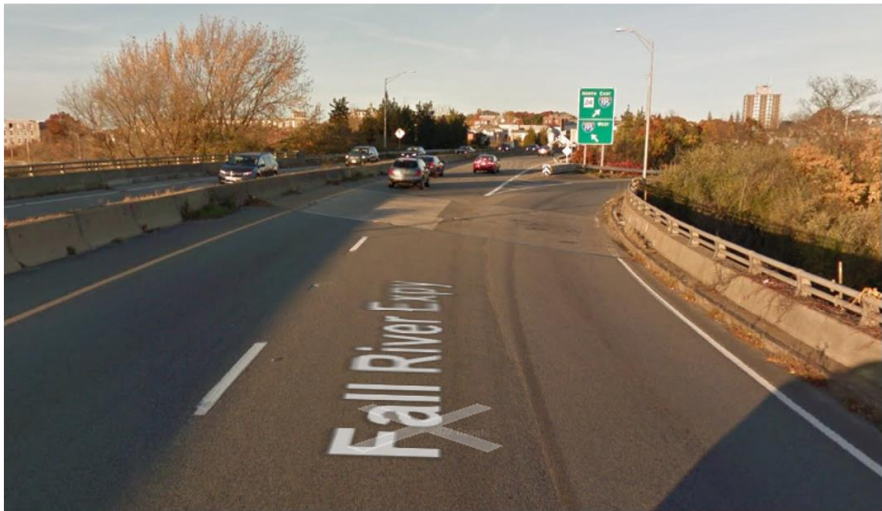
### Crash Narratives
